**REPORT
ON
LAND CAPABILITY ASSESSMENT**

**PROPOSED DEVELOPMENT
WESTERN SYDNEY PARKLANDS**

Prepared for
LANDCOM

**PROJECT 40465
JANUARY 2006**

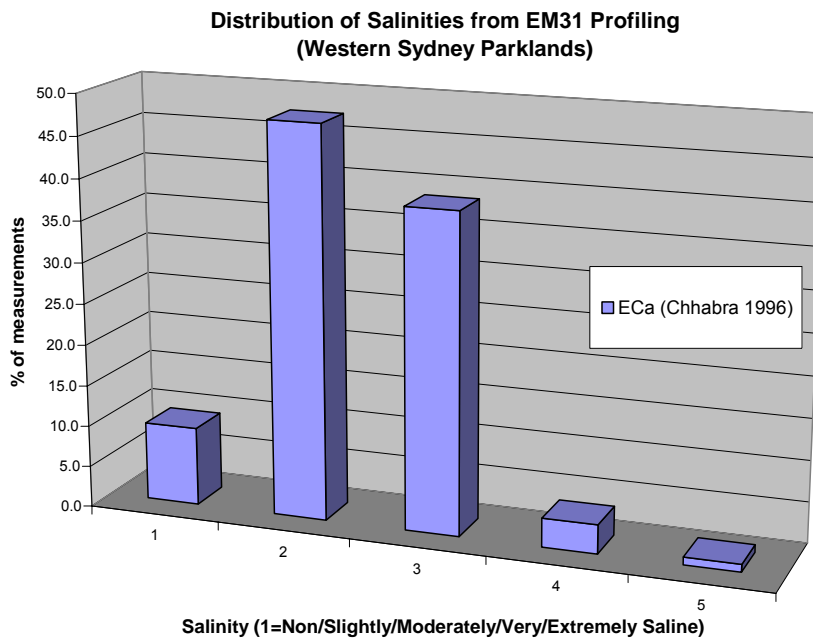
Figure 3: Distribution of Salinities from EM 31 Profiling

The histogram and table below show that of the 42 000 corrected and filtered apparent conductivity measurements over the study area, 57% fall in the non-saline to slightly saline classes of Chhabra (1996), with 39% in the moderately saline class and 4% in the very to extremely saline classes.

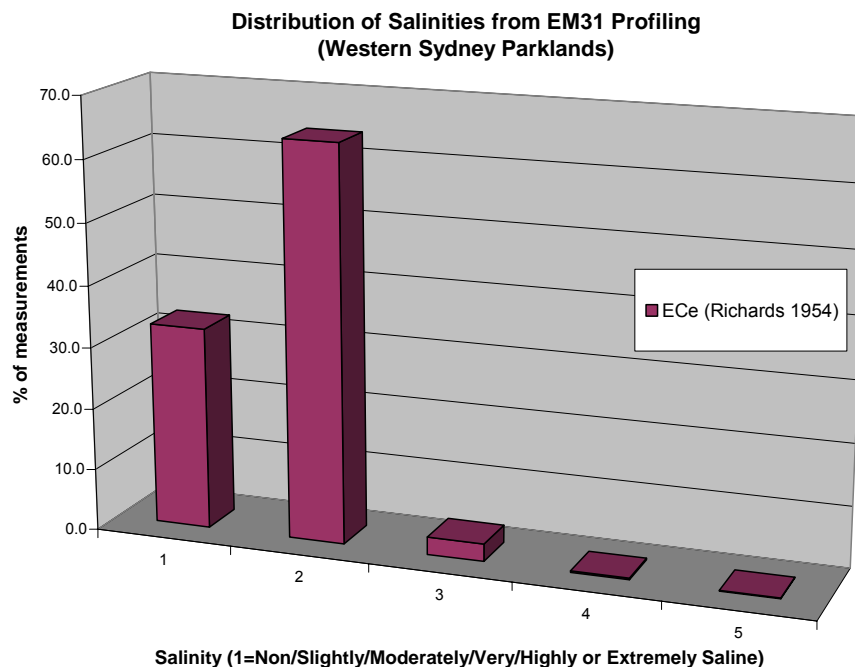
Figure 4: Distribution of Salinities

The factor was applied to all data, which was then re-gridded for presentation as an apparent salinity image (Drawing 7) with a continuous colour spectral scale in dS/m, based on the Richards (1954, Ref 9) classification scheme. The histogram and table below show that of the re-scaled data points, 97% fall in the non-saline to slightly saline classes of Richards, and 3% fall in the moderately saline class.
